## **Geotechnical Investigation into the Causes of Cracks in Building: A Case Study of Dr. Egbogha Building, University of Ibadan, Nigeria**

Prof. Agbede, O.A., Jatau, N. D., Oluokun, G. O. and Akinniyi, B.D.  
*Department of Civil Engineering, University of Ibadan, Ibadan, Nigeria.*

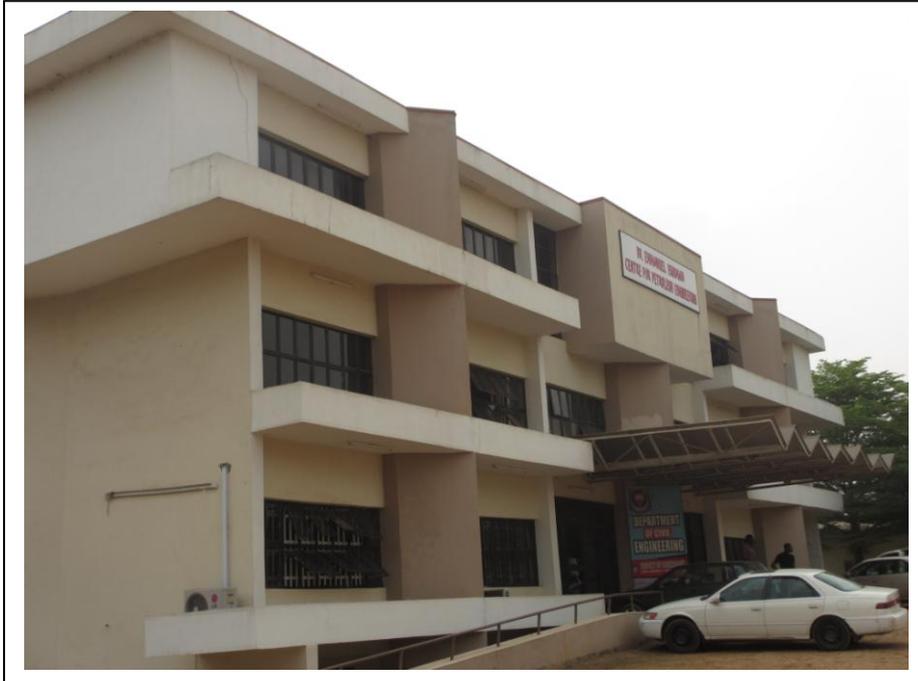
Plate 1: Photographic front elevation of Building under study

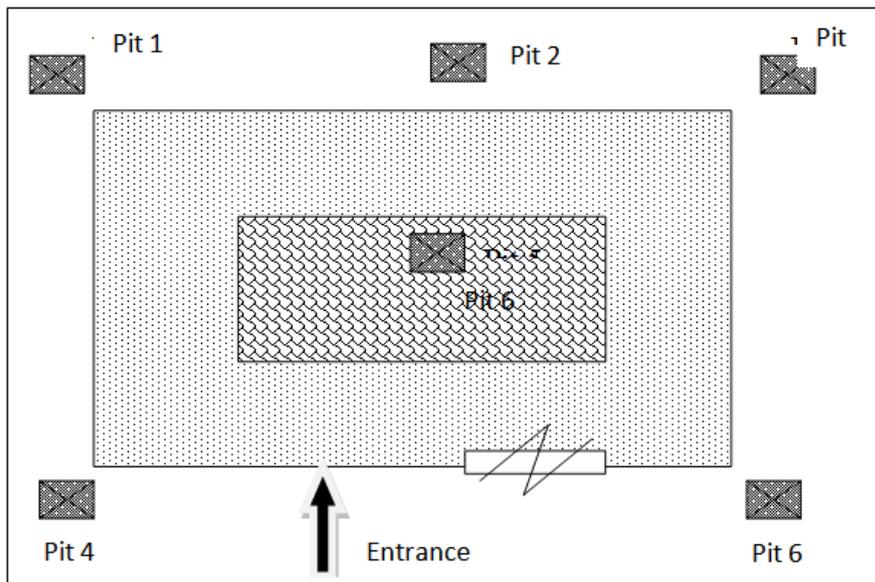
Figure 2: Cross section of sampling points around the structure

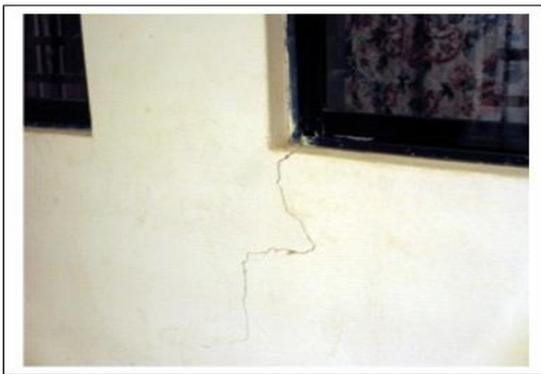
1. The foundation soil contains soil with sandy-clay soil possibly contaminated with inorganic silty soil.
2. The cracks are very growing from mild to severe, affecting the structural formation of the building (Plate 2a and b).
3. Settlement is not the major cause of the observed cracks on the building.
4. The cracks could be attributed to expansive soil supporting the foundation of the building. The soil foundation contains a considerably high amount of clay with high plasticity index
5. Water massively absorbed during raining season when dried up or withdrawn from the foundation during dry season could result in differential heave and the effect of this could be the observed cracks on the wall.

Plate 2a: Mild crack noticed on the structure

1. A proper and adequate drainage system should be constructed around the buildings to prevent continuous washing away of the building's foundation foot.
2. Sinking of boreholes or use of the equipment with dynamic load like blasting should be avoided around the structure because this could shake the building and increase the width of noticed cracks.
3. Timely repairs of cracks should be ensured. This will cut continuous effect of any further shaking of the building.
4. The usage of the building should be put under monitoring to avoid any overloading of the structure.
5. The foundation supporting the structure should be under further soil settlement investigation.

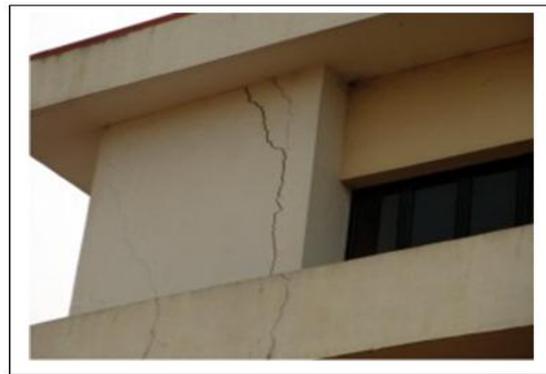
Plate 2b: Severe cracks noticed on the structure
