A Case Study on construction repair of Syncrolift from Ship Fallen Accident

ABSTRACT : During Ship landing from Syncrolift, an accident has occurred due to wire broken, ship has been fallen into water from small height, broken wires are two from thirty-two wires. Although no damage has occurred to the ship (weight 3500 ton) and no injury to the ship operating group, the steel deck has been partially damaged. This study is addressed to evaluate the existing situation and choose the optimum repairing method for the system. Instantly, survey impact has been performed to record the generated deformations and discrepancies from the original pattern. Applying FE Method by Abaqus software, the fallen action has been simulated, upon which the damaged parts have been identified. Approximate analysis shows one of the main girders needs full jacketing (for the web and flanges). To optimize the real needed work another exact analysis has been performed showing the exact location of failed areas and damaged stiffeners. Partially removal of the girder top flange has been performed, new elements have been welded, and deflected stiffeners have been replaced.

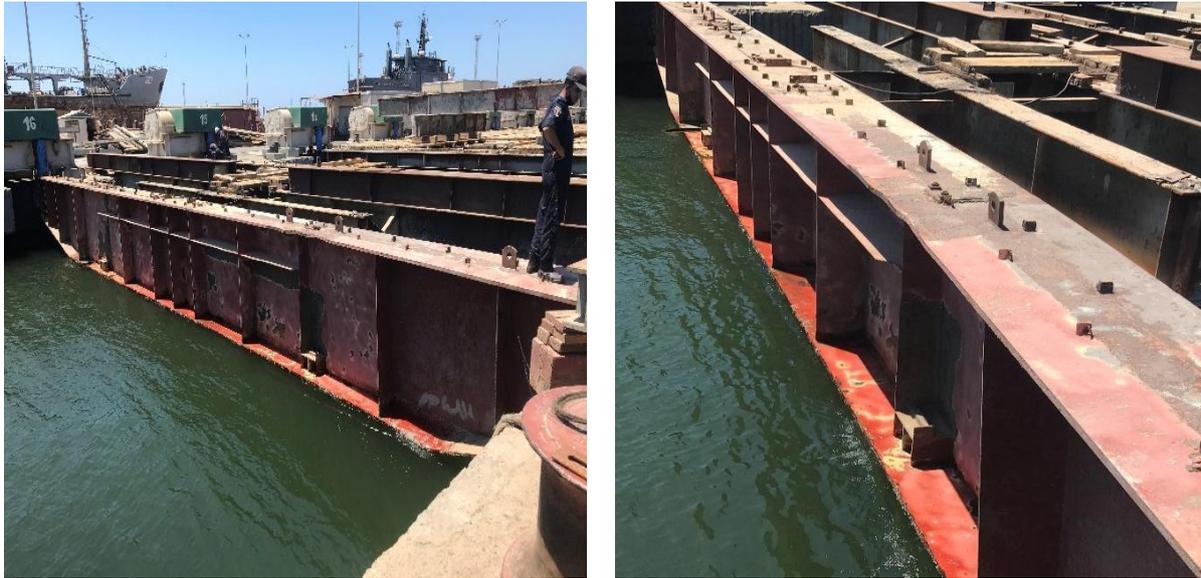
Figure 4: Deformation in the main girder

After lifting the articulated unit from the sea ground, the supported adjacent panel has been lifted to maintenance levels and supported by four steel blocks. Visual check shows deformations in the main side girder (just beside the articulated fallen unit), other deformations are shown in the transverse bracing elements as shown in Figure 4.

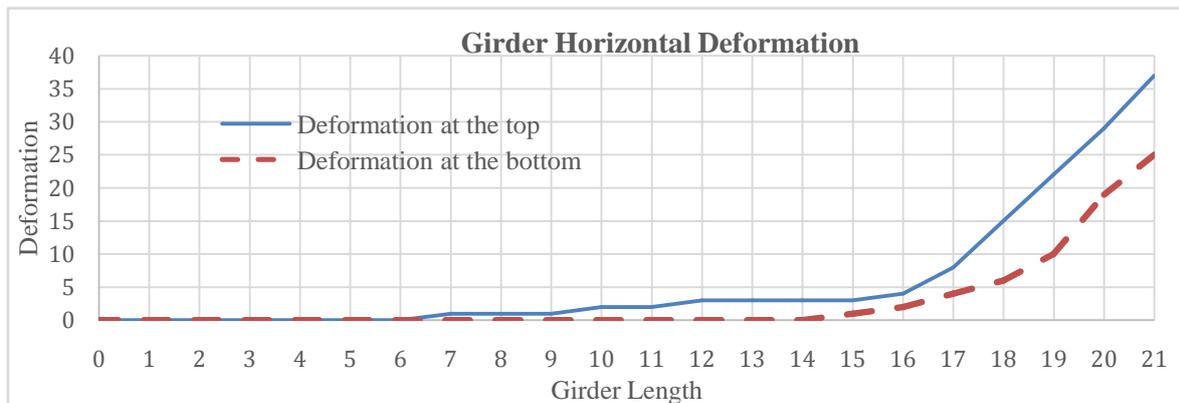
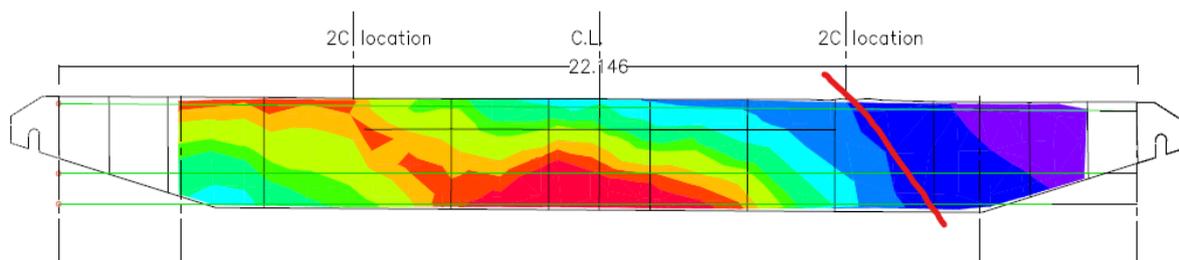
Figure 5 : Deformation records in the girder's web

Detailed measurements have been recorded using total station devices for all the unit members. Main concern is to determine exactly the developed deformation at each region of each member. The records show severe bending in the main girder, resulting deformation at the girder end with 40 cm horizontally and 7 cm vertically, associated with obvious buckling at the top flange, and slightly buckling in the lower flange. Web stiffeners are buckled in this region. It is nothing to see the deformation in the girder occurred as it has been bent around inclined axis, due to the lower connection with (2C) girder as shown in Figure 5.

This proof that plastic hinge has been developed along the inclined axis. The intensity is significantly high at the top and decreases gradually toward the bottom flange. It can be seen clearly the top flange is severely buckled, while the bottom flange is slightly affected as shown in Figure 6

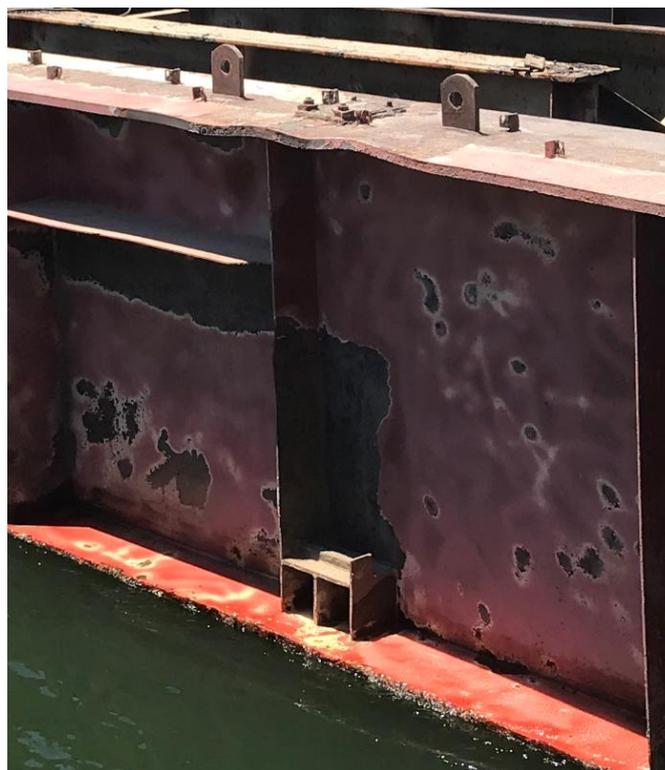
Figure 6 : Top and Bottom Flanges buckling pattern

The vertical stiffener and the attached horizontal stiffener have been dramatically deformed, which require removing it completely during the repairing process. In the same manner, the transverse bracing above the longitudinal beam (2C) have been completely buckled.

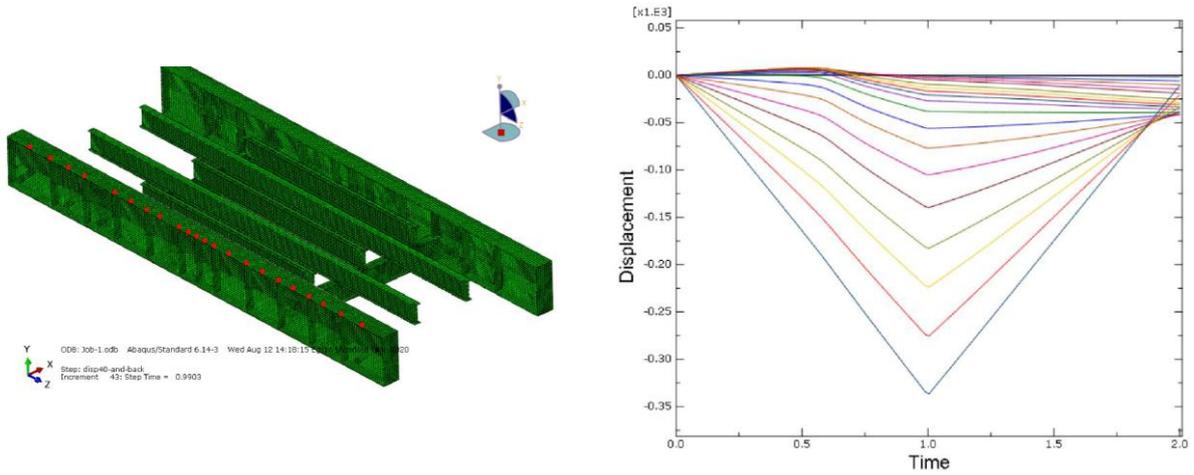
Figure 8: Deformations at the top flange

Two-point series have been chosen on the lower and upper flange, to track the displacements and stresses. The time-deflection curves for the top and bottom flanges chosen points are shown in Figure 8 and Figure 9 respectively. It is obvious to see that, first repairing step has achieved straightening with tolerance less than three millimeter, which is accepted.

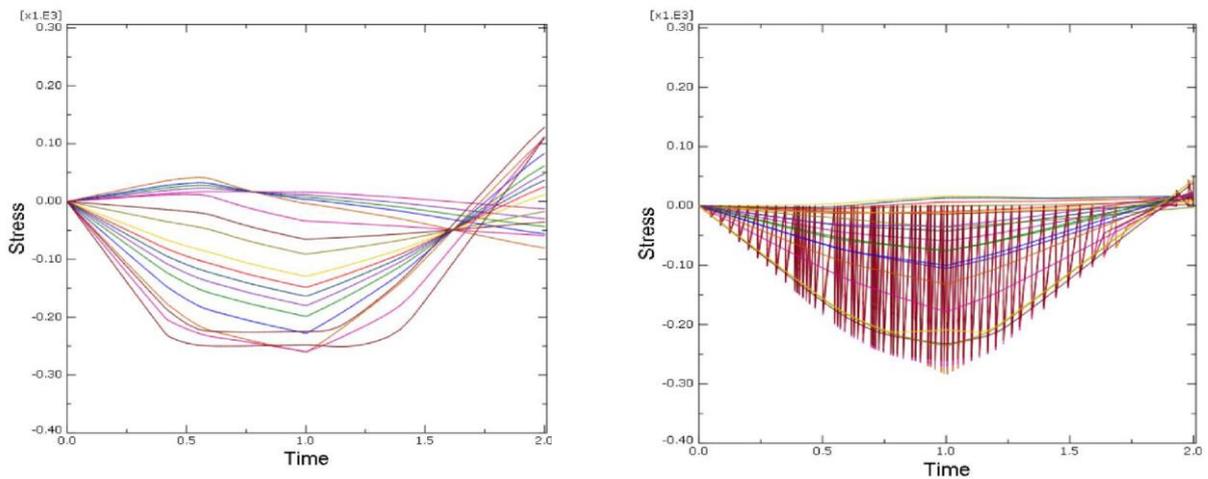
Figure 10 : Developed and residual stresses at the top and bottom flanges

The von Mises stress result under the occurred displacement is shown in Figure 10. The stress-time curves show obviously when the girder is straightened with residual stresses in the top flange exceed 20% of the material yield stress while it is less than 5% in the lower flange. The top flange is significantly yielded, and it is required to be replaced while the bottom flange contains slightly residual stresses, which is within the design margin. The residual stresses in the web is less than 3% and all the straining actions have been grabbed by the buckled stiffeners as shown in the detailed view in Figure 11.

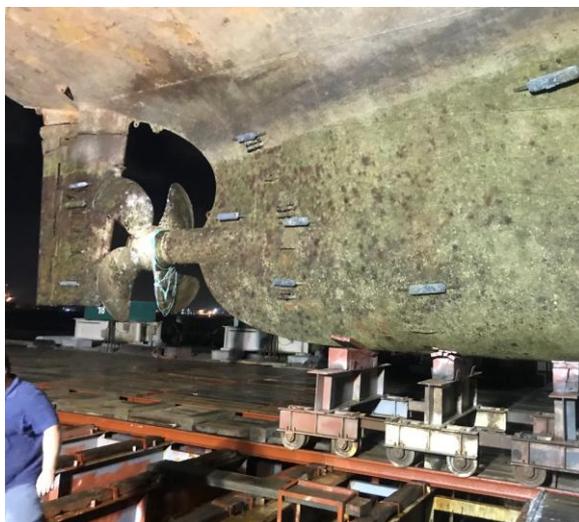
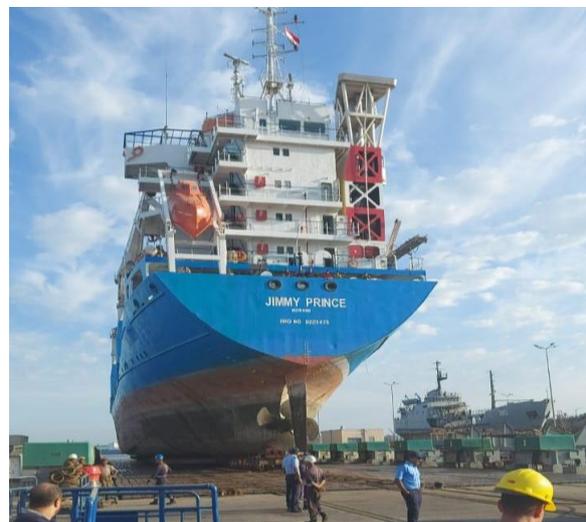
Figure 14 : Ships Loading

Loading tests have been done, especially on the repaired unit, by loading an antiquated ship as shown in Figure 14-a. Deflection has been recorded in loading and unloading stages, and compared with the permissible limits. After getting confidence from the behavior of the system as all, the normal ship has been loaded and moved to inshore with a total weight of 3500 ton as shown in Figure 14-b. Deflection values have been recorded during lifting the ship and moved to the working ground. All values are within the limits as before the accident.
