# Defect Pattern Analysis of the Alloy Steel Ingots through Scanning Electron Microscopy, Energy Dispersive Spectroscopy and Ultrasonic Test after Forging

**ABSTRACT :** In this study, the types and causes of defects found after forging and machining were analyzed for four alloy steel ingots. Forged carbon steel, silico-manganese steel, hardenability chromium molybdenum steel, nickel chromium molybdenum steel, which have undergone casting and heat treatment processes, were used as specimen materials. Ingots were produced through EAF, LF, VD, casting and slow cooling processes. The chemical composition of the alloy steel was analyzed by XRF instrument. The defects of machined ingot specimens were analyzed using ultrasonic test, scanning electron microscopy, energy dispersive spectroscopy, and optical microscopy. The most frequent ingot defect patterns in the four specimens in this study were non-metallic inclusions. As a result of SEM analysis, it seems that the cause of defects in the ingot defect part is a mixed component of the exothermic material and the de-oxidation product inclusions. It seems possible to predict cracks by simultaneously considering the internal crack tempera

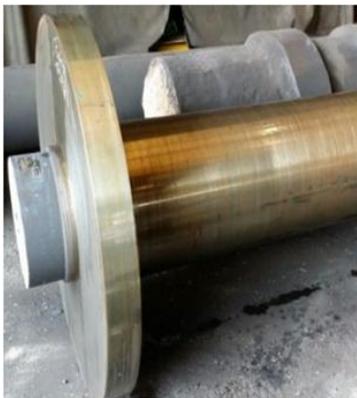
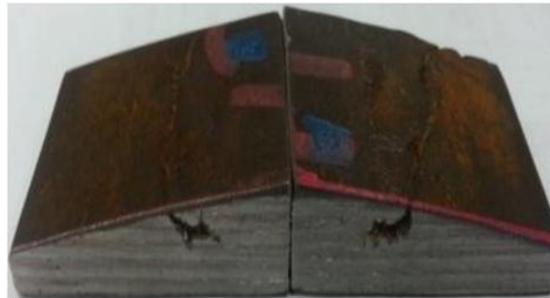
Figure 1. The sample shape of the previous stage for slice specimen

Fig. 1 shows the shape of the ingot and the collected specimen before preparing for the slice specimen among the four specimens used in this study.

(a) Alloy steel ingot(b) Specimens shape

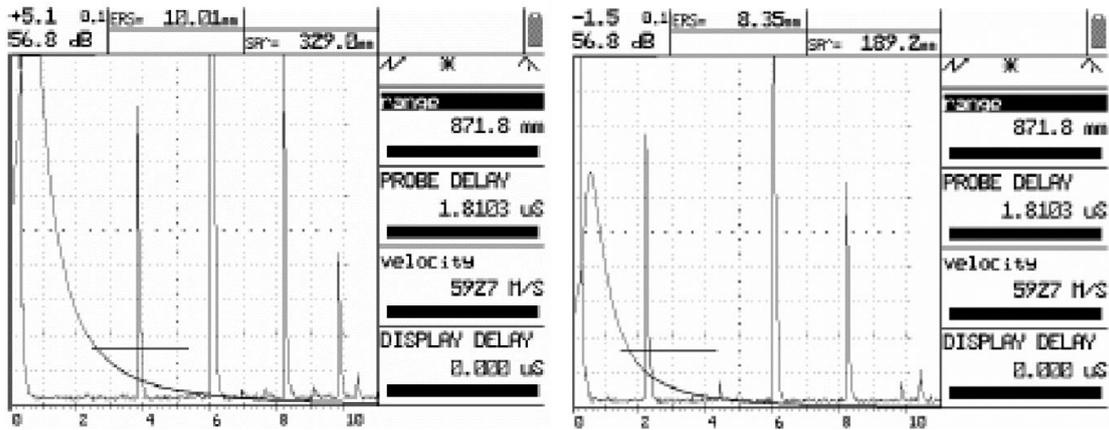
Figure 2. Defects indication pattern by V-type segregation zone in the center of the FCS

The results of distinguishing defects between voids and cracks for four types of alloy steel through ultrasonic testing are shown in Fig 2 and Fig. 3. As the incident wave collides with the crack tip, the diffraction

amplitude varies depending on the reception angle. It was found that the shape and size of voids depended on the reception angle of the incident wave scattering and the amplitude of the scattered wave[6].

(a) Indication size:  $\varnothing$  10.01 mm  
Indication depth: 329.8mm

(b) Indication size:  $\varnothing$  8.35 mm  
Indication depth: 189.2 mm

In the top part of the ingot, positive segregation was formed, and in the center of the ingot, a V segregation zone appeared. According to the ultrasonic flaw detection, the defect occurred in the V segregation zone was Porosity, Porosity in the V segregation zone led to defects due to lack of forging ratio after forging.

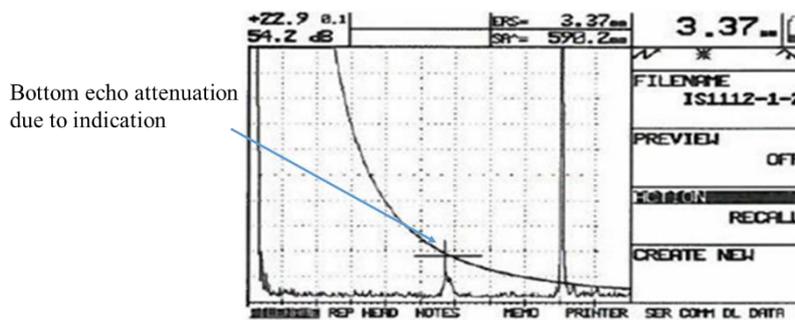
Figure 3. Defect indication pattern by sedimentary crystallization zone in the FCS  
: Inclusion trap pattern

Indication size:  $\varnothing$  3.37 mm , Indication depth: 590.2 mm

The effect of pressure on the heat transfer boundary condition is considered to be that gravity, buoyancy and drag forces play a key role in the movement behavior of inclusions during the solidification process.

This is consistent with the report that increasing the pressure near the columnar dendrites reduces the inclusion concentration of the ingot and makes the inclusion distribution more uniform because the inclusion trapping ability is weakened[7].

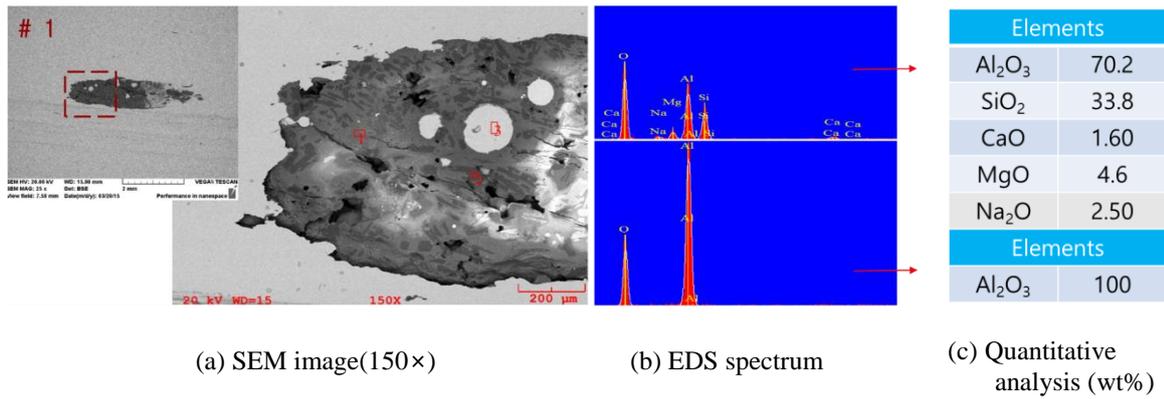
Figure 4. SEM image and EDS analysis of the flaws on FCS #1

The SEM images and EDS analysis results of the defect zone of specimen FCS are shown in Fig. 4 and Fig. 5.

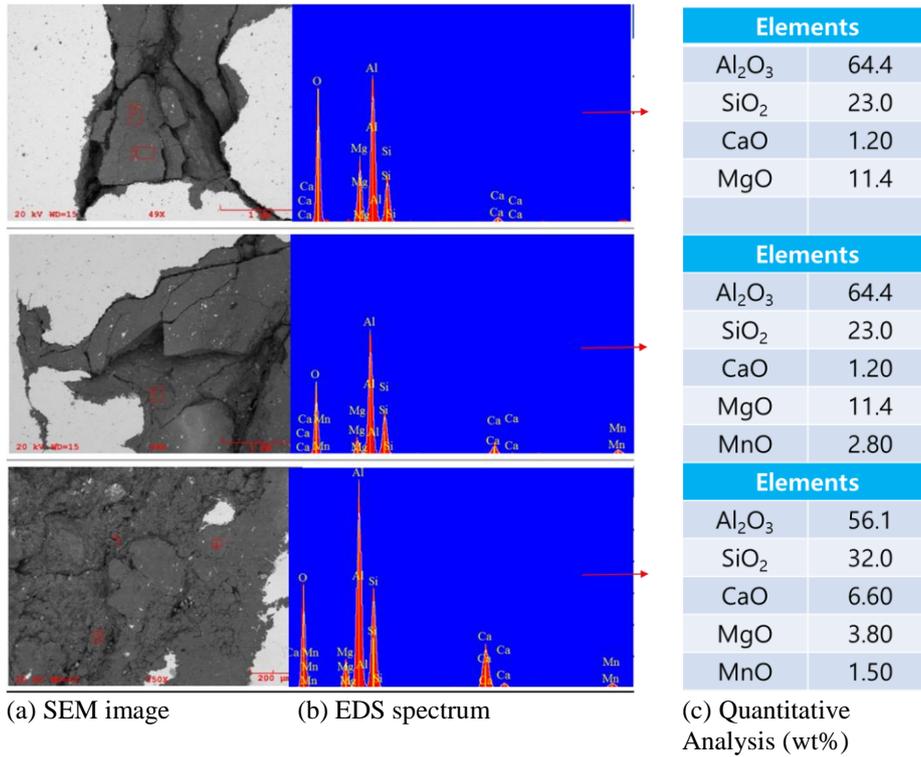
Figure 6. SEM image and EDS analysis of the flaws on SMS

Fig. 6 shows the scanning electron microscopy image and energy dispersive spectroscopy analysis results for defects in specimen SMS.

The non-sulphide macro-inclusions observed were present in the ingot and the size distribution increased as the size decreased. The inclusions are uniformly distributed within the horizontal section of the ingot, but more numerous towards the bottom[10].

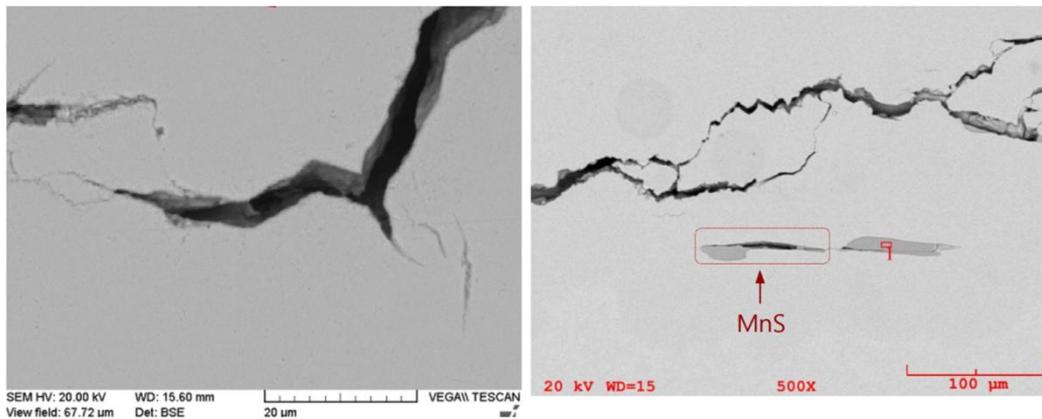
Figure 7. SEM images of the crack fracture zone on NCMS after forging

(a) Crack zone (b) MnS voids morphology of the crack zone (500×)

Fig. 7 shows the SEM image of the crack fracture identified in the specimen NCMS after forging. A crack observed in the forging ingot as the result of increased amount of the sulphur source.

Macro-surface cracks and sub-surface micro-cracks were analyzed as being caused by non-metallic inclusions of alumina and oxide types.

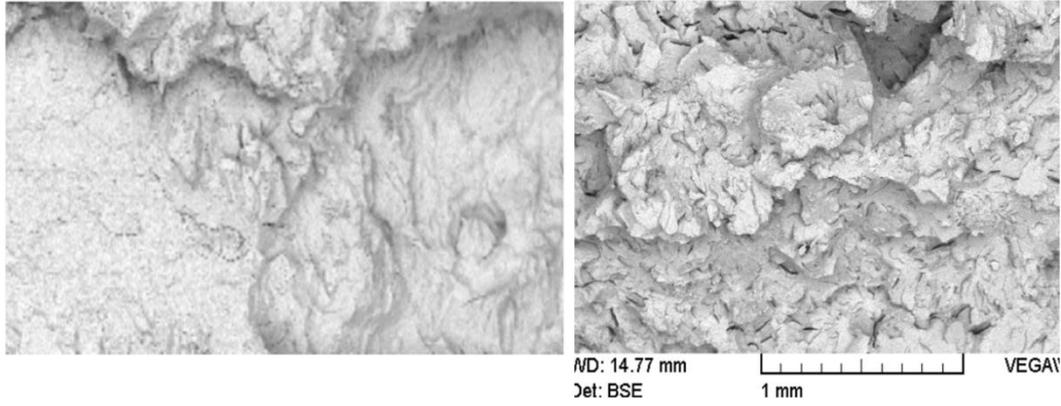
(a) forged crack surface (b) forced fracture surface  
 Figure 8. Surface morphology difference of the forged crack and forced fracture surface on NCMS

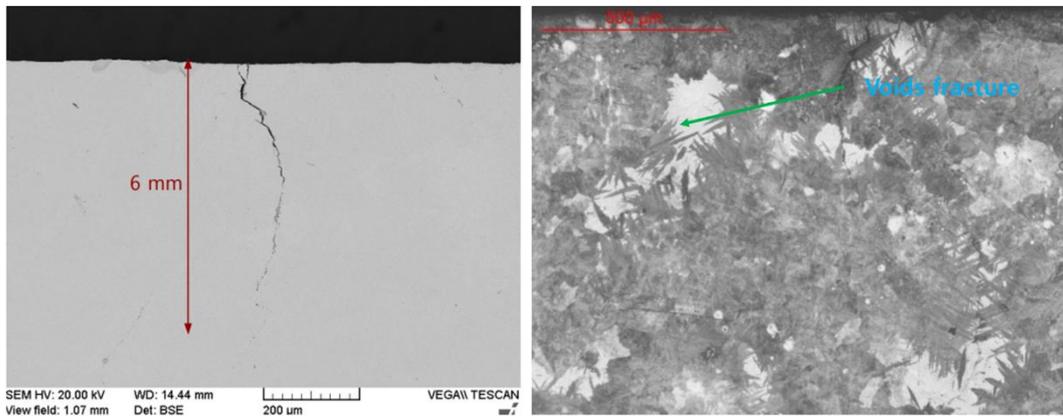
Figure 9. Crack pattern along with brittle band structure of the NCMS after forging

(a) Vertical crack depth from surface (b) Voids fracture image against crack direction

Cracks were generated along the brittle band structure in MnS around the cracks, and these defects are considered to be caused by hydrogen.

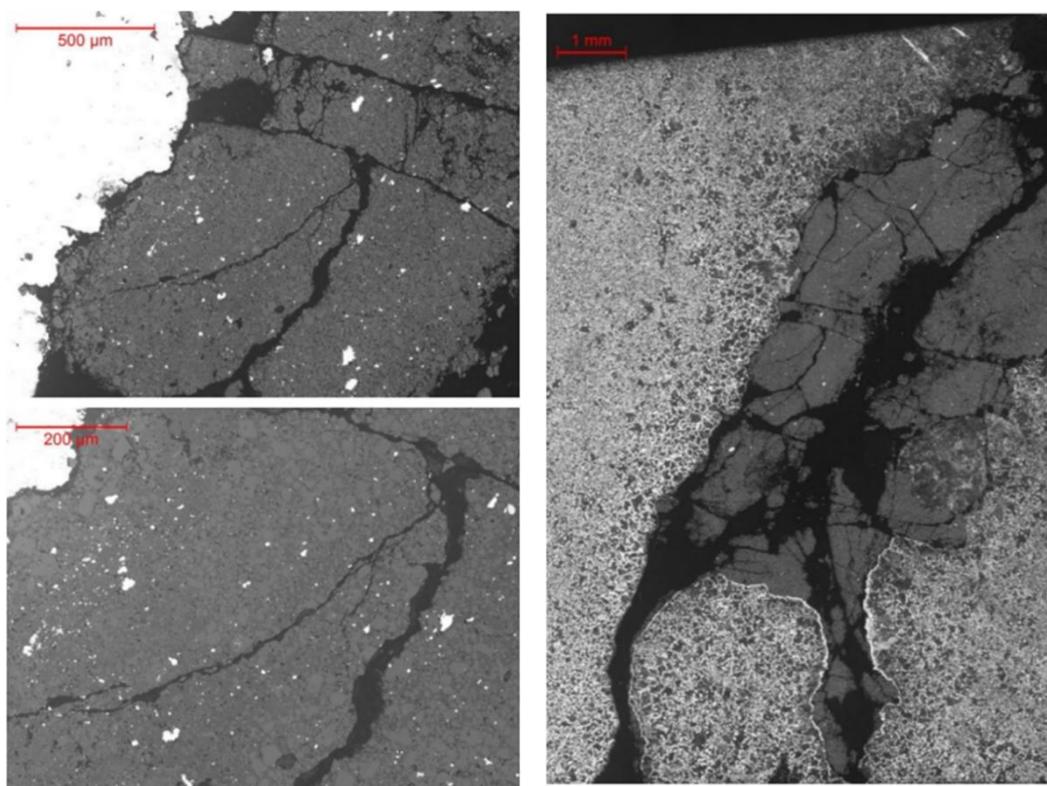
Figure 10. Crack zone image of SMS surface by the optical microscope after forging

In silico-manganese steel (SMS),  $\Phi 4$  inclusions caused by exothermic source + de-oxidation products were confirmed on the indicator.

The main components of the inclusion were  $\text{Al}_2\text{O}_3$  and  $\text{SiO}_2$ , and it was confirmed that an inclusion trap was formed in the bottom solidification part due to the endothermic reaction of the exothermic material including  $\text{Fe}_2\text{O}_3$ ,  $\text{TiO}_2$ ,  $\text{CaO}$ ,  $\text{MgO}$  and  $\text{Na}_2\text{O}$ [13].

(a) Crack due to little inclusion zone

(b) Crack due to massive inclusion zone

The result of observing the crack zone image on the surface of the specimen SMS by an optical microscope after forging is shown in Fig. 10.
