## Water Quality Assessment of VIT University “Green” Lake Using GIS

**ABSTRACT :** VIT University “Green” Lake is a manmade lake present in VIT University, Vellore. The lake is primary used for disposal of treated industrial water and enhancing the aesthetic value of the University. As the population density area is really high the lake water pollution has affects the lives of the students directly. The purpose of the project was the determination of spatial variation of different physic-chemical characteristics of lake water viz. Chlorides (Cl<sup>-</sup>), Alkalinity, Dissolved Oxygen, Turbidity and hardness using Geographical Information System (GIS). Analysis provided the evidence of eutrophication and its effects on previous characteristics.

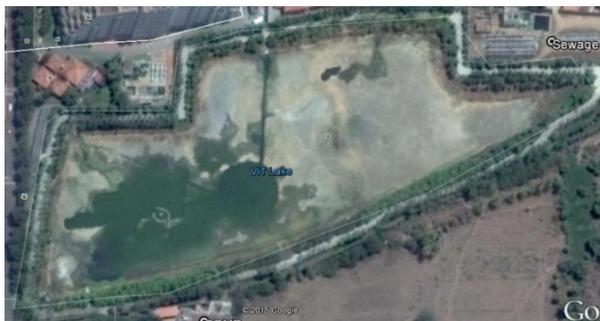
Figure 1: Satellite View of VIT University i.e. Green Lake

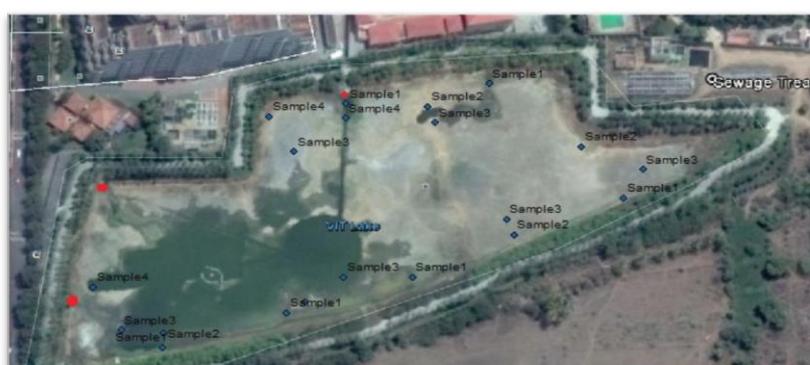
The samples were collected with help of gardeners provided by the VIT University during the months from August 2014 to November 2014. Photos of the site were captured to pin point the site on the map. Samples were stored in sterilized bottles carefully and preservation was done according to APHA standards.<sup>1</sup> Water from deeper places was collected using a plastic tumbler attached to a stick. A total of 20 samples, about 500 ml in each bottle were collected for analysis. DO analysis experiments were performed on the site and hence instruments were taken to the lake itself. It is to be noted that only surface water was collected at deeper and shallow places to ensure uniformity in the readings. Figure 2 illustrates the site from where the samples were collected. Spots in red colour were the point sources or the source of effluents.

Figure 2 Different sites chosen for sample collection

Figure 3 confirms that the pH is highest at the two bottom corners of the lake while decreasing slightly as we move towards the middle and then increasing again. After comparing figure 2 and figure 3 it was inferred that as we are closer to the point source the ph is slightly lesser as compared to the corners and increases again in the middle.
