Road Safety Audit of Delhi – Mathura Road

Abstract: Road Safety audit is the formal procedure for assessing accident potential and safety performance in the provision of new road schemes, the improvement and rehabilitation of existing road and maintenance of roads. The role of the auditor is to provide independent advice in the form of written recommendations. This paper explores the defects in the design and other safety features. This study highlights even the psychological factors involved in understanding the behavior of pedestrians and vehicular traffic. The main tool is Road Safety Audit. The road selected for this study is Delhi to Mathura road near CRRI, construction site at Mewala Maharajpur Station & Okhala Interchange. This audit is a part of CRRI Road Safety Audit Training Program. In conclusion, we argue that significant measures should be taken on Road Safety aspects to mitigate the accidents and ensure the safety to pedestrians and vehicular traffic.

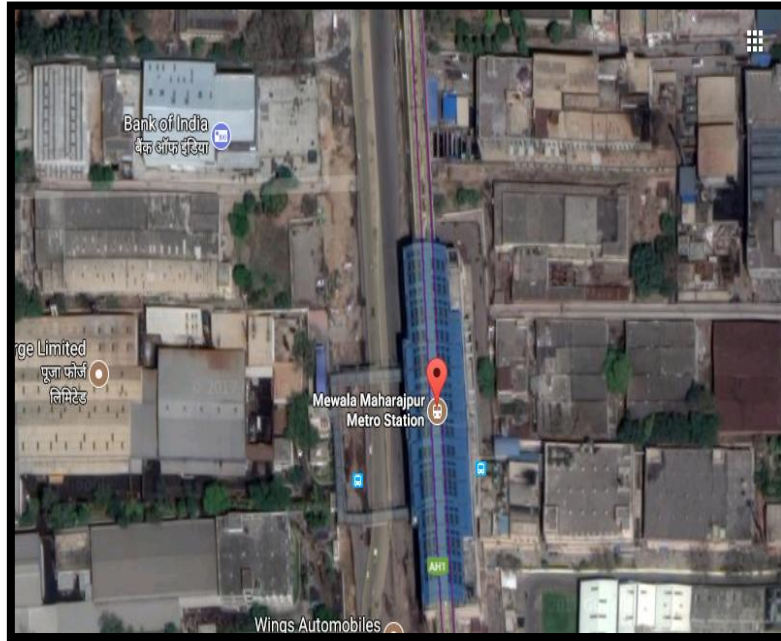
Figure 1 The above image shows the Mewala Maharajpur metro station.

Construction was going on at this area. They allowed even the traffic near the construction without proper safety measures which is causing the hazard and accident-prone area. Some of the factors like whether the transitions from the existing road to the site of works safe and clearly laid out, whether the sight distance and stopping distance adequate at site of works safe and clearly laid out should be checked.

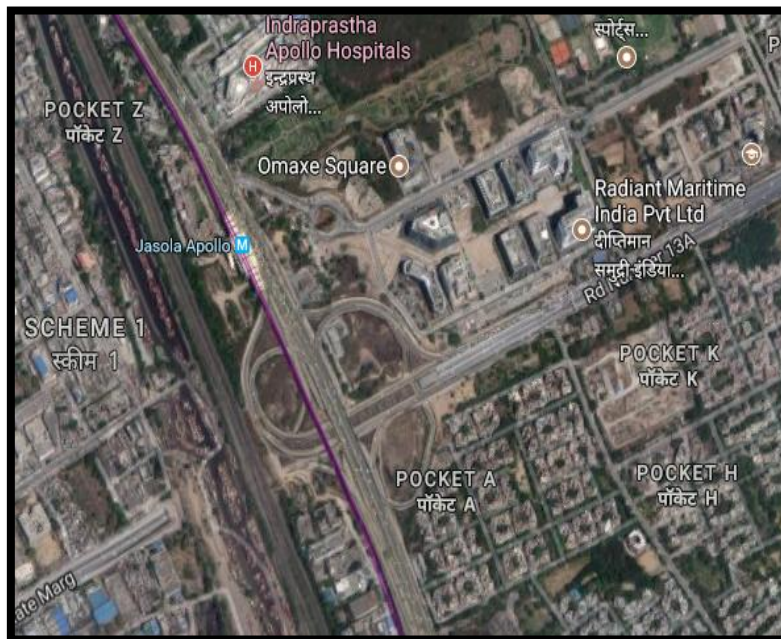
Figure 2 Image showing OKHALA Interchange

Interchange connects various roads and directions. We have noticed few issues which may be considered like structural defects and some safety issues related to vehicle traffic. Improper sign boards creating a confusion to the drivers. Some of the factors like is the layout encourage slow controlled speeds at and the approach to stop/ give way lines and other critical decision points, is the provision of night time lighting adequate, if not what are the deficiencies.

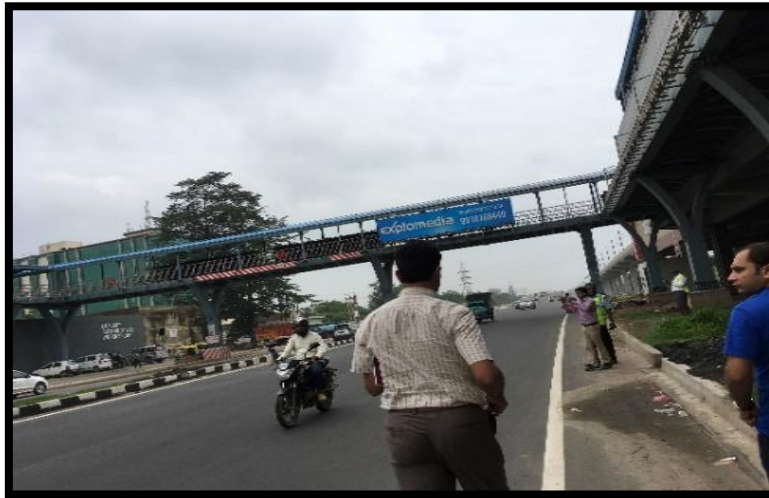
Figure 3 The column of the foot over bridge near to the carriage way

Pillar of foot-over-bridge is hazardous as it is very near to the main carriageway.

Any driver if loses control on the steering may hit the pillar which may be fatal.

The foot-over-bridge should be re-designed to relocate this pillar away from the footpath.

Priority: Essential.

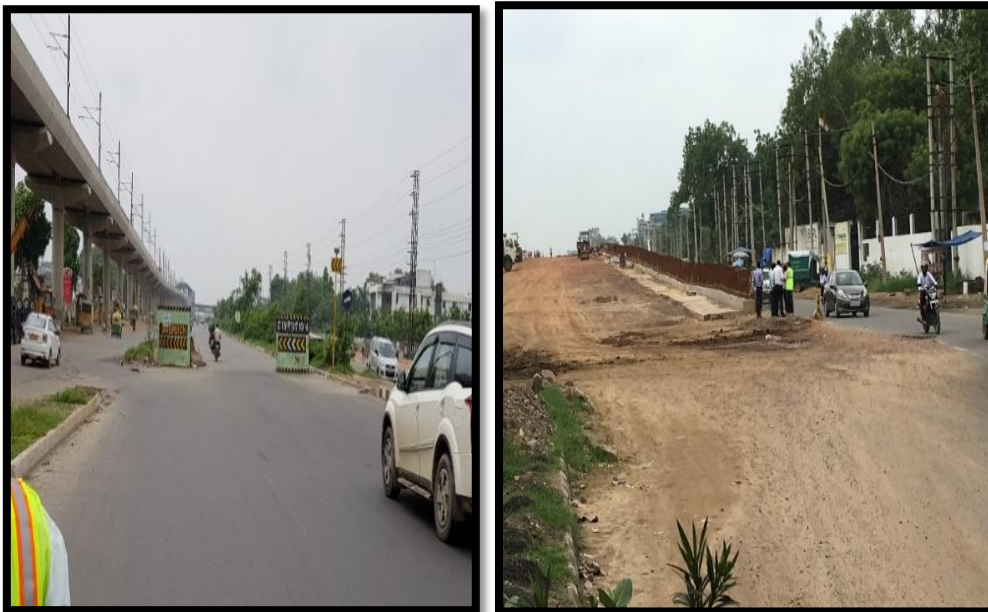
Figure 4 Open Entry to construction site

Open Entry to construction site

Traffic from the main carriageway is entering to the construction site, they must come back after realizing the mistake.

A flagman shall be deployed at the entrance to guide the traffic to use the diversion.

Priority: Highly Essential.

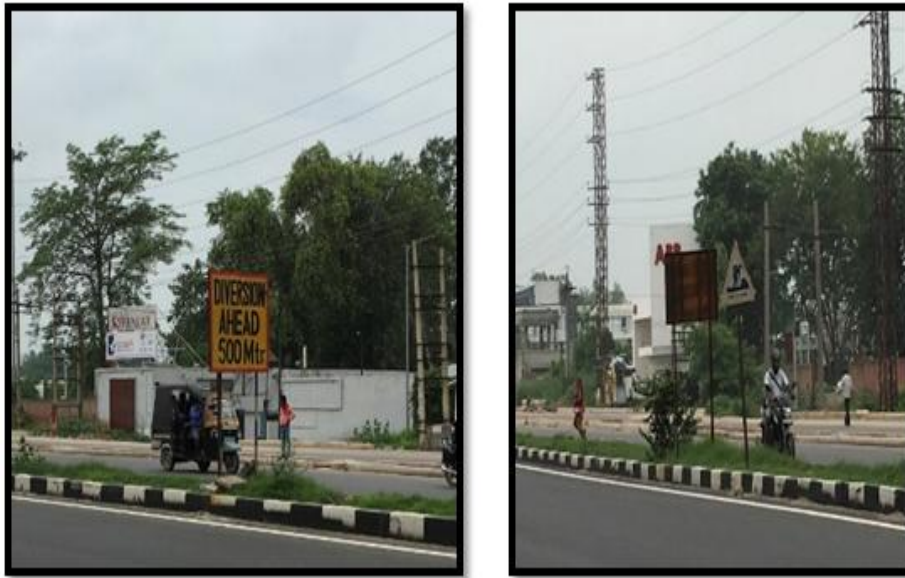
Figure 5 Sign boards without retro-refractory background & Men at Work is faded not visible clearly

Sign boards without retro-refractory background and reused old ones.

Visibility in night is not clear as there is not reflection of the background yellow color. Vehicle users directly enters the construction site and may hit any objects. Road user do not get the clear information about the work site. To get alert while driving.

The diversion signage and men at work signage shall be replaced with the new retro-reflective signs to avoid the accidents in night.

Priority: Highly Essential.

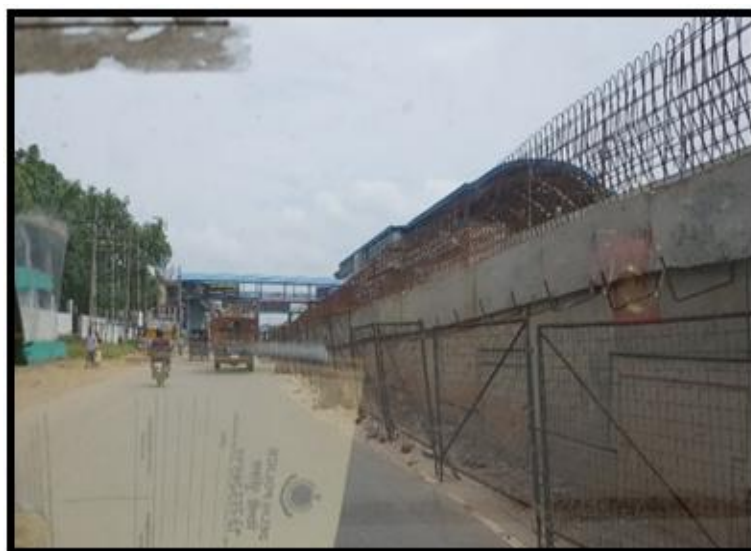
Figure 6 Barricading of working area causing hazard

Barricading of working area of the retaining wall (Approach to the flyover) with the help of wire mesh along with angleposts not placed properly. Some of the wire mesh & angle posts are damaged and exposed towards the carriageway.

It is exposed to the direct road users may cause accidents in night as it is not visible in dark hours.

The barricading provided to the working area with the MS sheets properly welded to the angle posts and with the retro-reflective signs should also be provided.

Priority: Essential.

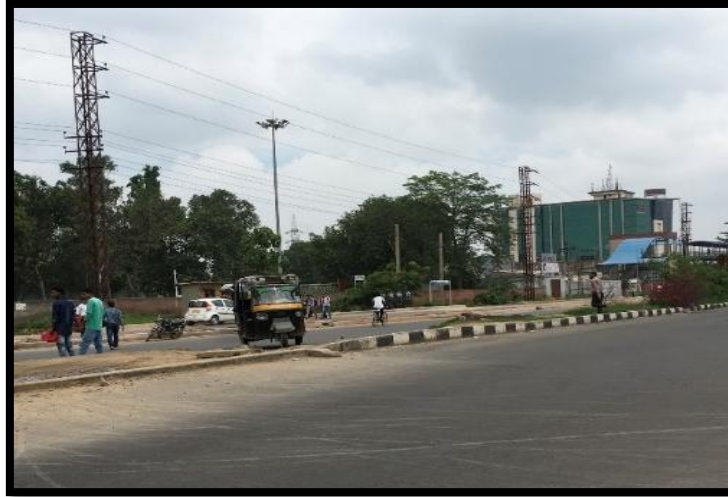
Figure 7 Vehicles climbing over the median due to damaged median.

Vehicles climbing over the median due to damaged median.

Major obstruction to the traffic coming on the other side of the road and this may be the hazard to the oncoming traffic.

Median shall be restrained/repared and proper U turn shall be provided

Priority: Essential.

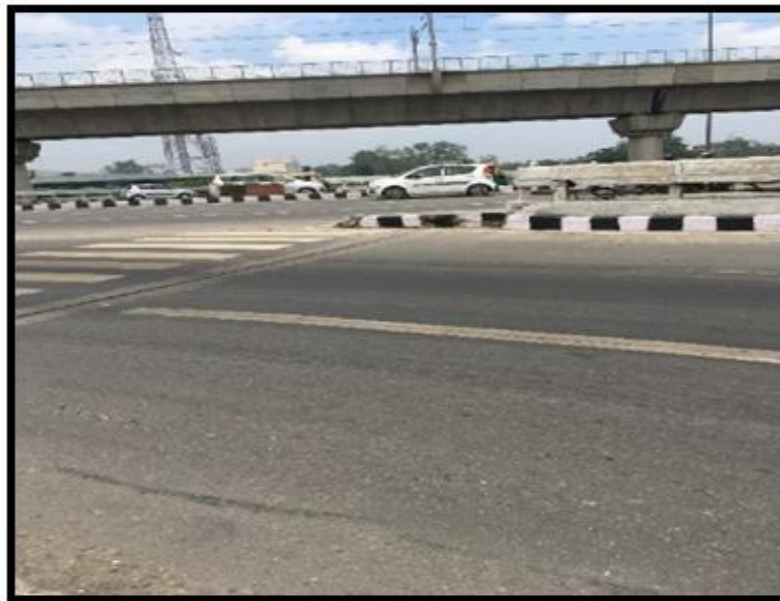
Figure 8 zebra crossing on the flyover.

Zebra crossing on the flyover

Zebra crossing is not necessary on the flyovers or ramps, as pedestrians are not allowed on it. This creates the unnecessary disturbance to the riders. This also encourages the pedestrians to use the flyover, which is a great harm to them.

Pedestrian should not be allowed on the flyovers and the zebra crossing marks need to be removed

Priority: Essential

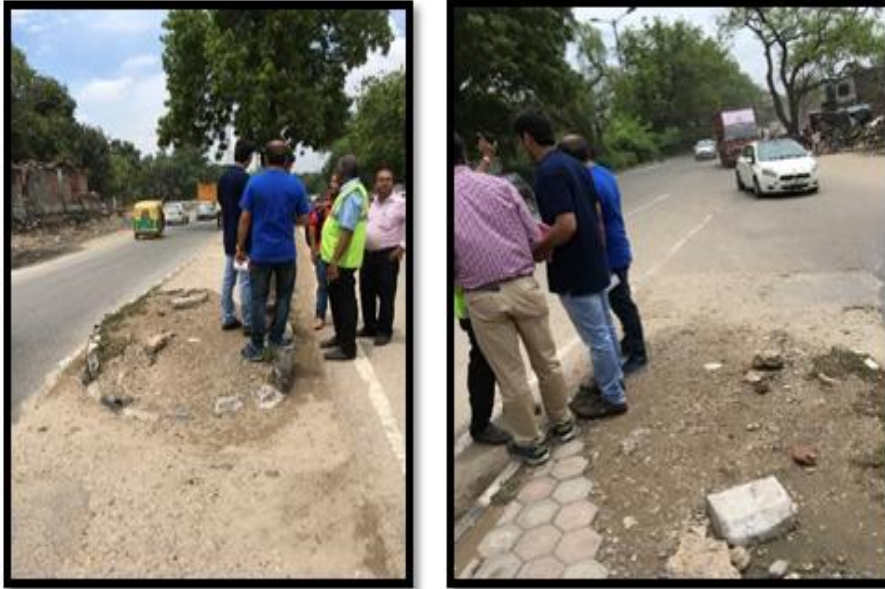
Figure 9 median without sign board and no acceleration lane

Sign boards were not provided at the opening of the median & acceleration lane is not provided.

It is a dangerous threat to the vehicular during night. Acceleration lane is not provided for climbing the ramps, this had been a very difficult to the heavy vehicles and this is causing the traffic slow movement

Proper sign board need to be provided and acceleration lane need be provided for the smooth flow

Priority: Highly essential

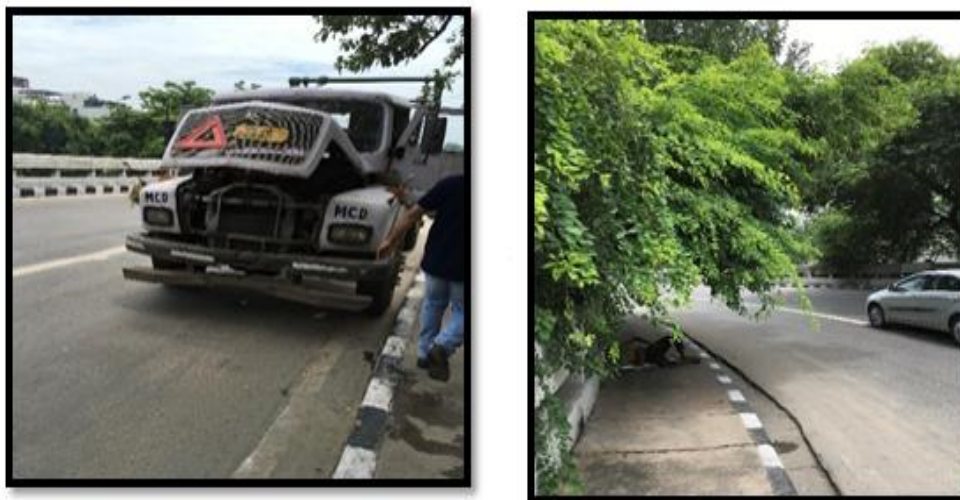
Figure 10 Heavy truck parked on the acceleration ramp & bushes causing the blind spots during acceleration operation and it has a sharp curve

Heavy truck parked on the acceleration ramp & tress, bushes causing the blind spots during acceleration operation and it has a sharp curve

Parking vehicles can create a blind spot and they will be as an accident causing elements on roads. Sharp curve is not good in terms of sight distance

Strict provision should be there to avoid the stopping or parking of vehicles on ramps. Direction signs need to be provided to indicate the turning direction

Priority: Essential
