A Case Study on construction repair of Syncrolift from Ship Fallen Accident

ABSTRACT : During Ship landing from Syncrolift, an accident has occurred due to wire broken, ship has been fallen into water from small height, broken wires are two from thirty-two wires. Although no damage has occurred to the ship (weight 3500 ton) and no injury to the ship operating group, the steel deck has been partially damaged. This study is addressed to evaluate the existing situation and choose the optimum repairing method for the system. Instantly, survey impact has been performed to record the generated deformations and discrepancies from the original pattern. Applying FE Method by Abaqus software, the fallen action has been simulated, upon which the damaged parts have been identified. Approximate analysis shows one of the main girders needs full jacketing (for the web and flanges). To optimize the real needed work another exact analysis has been performed showing the exact location of failed areas and damaged stiffeners. Partially removal of the girder top flange has been performed, new elements have been welded, and deflected stiffeners have been replaced.

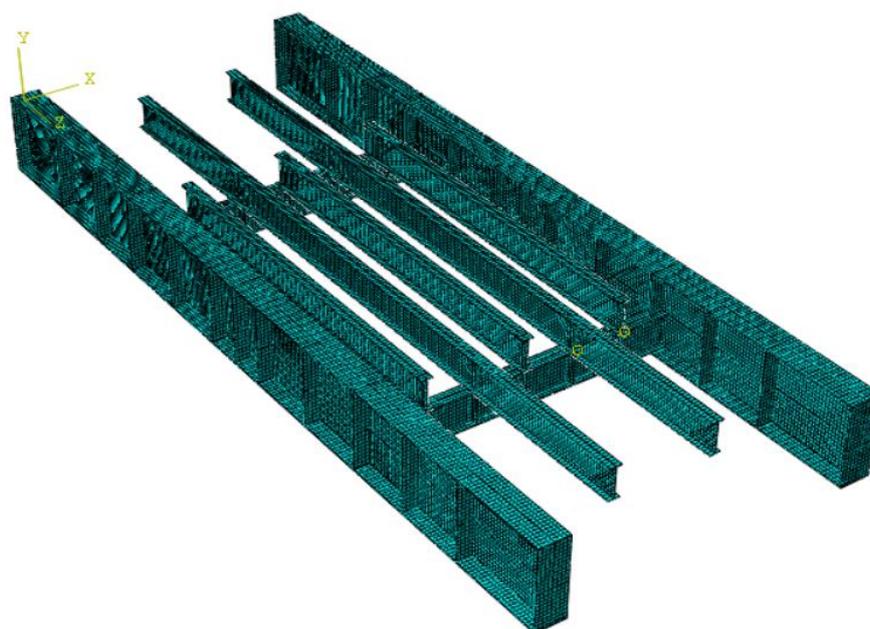
Figure 7: Damaged unit Assembly with meshing

All of the unit elements are modeled with solid elements, the type is C3D8R. Details of the mesh are shown in Figure 7, it meshed in structural technique.

FE model had roughly 45,456 elements with 530,592 degrees of freedom and the analysis has been run on a PC with five cores processor.
